LOWER POND DAM

VT 00059

PHASE I INSPECTION REPORT
NATIONAL DAM INSPECTION PROGRAM

JULY 1979

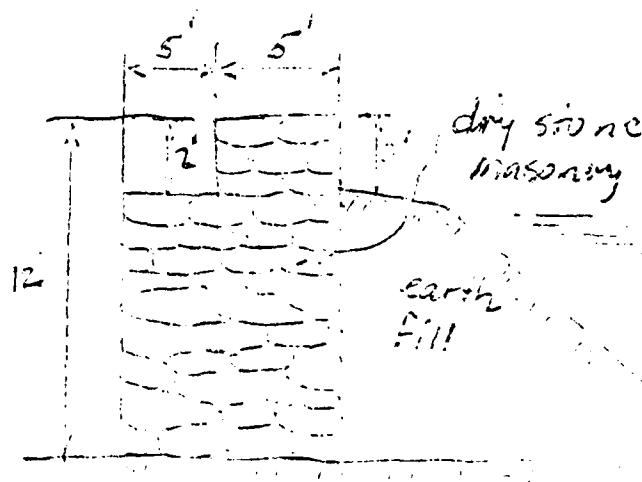
Fig. 2 - Typical Section,
Lower Reservoir Dam

This dam is also of dry stone masonry with an upstream blanket of earth fill. Its typical section is indicated in Fig. 2. The masonry section is about 250 ft. long, 10 ft. thick, and 12 ft. deep. In the center is a crudely formed overflow notch 14 ft. long and 1 ft. deep. Here the downstream face is indented to make the masonry section about 5 ft. thick. This section also contains a regulated outlet at its base, consisting of a 2 ft. dia. steel conduit controlled by a valve. The structure is on an earth foundation.

The dam has weathered well and its general condition is satisfactory. Stability is enhanced by the large boulders used in its make-up. The dam is of ample section except at the spillway. (greatest depth) At this point, the indication is that some movement has taken place, but has not entirely weakened the section.

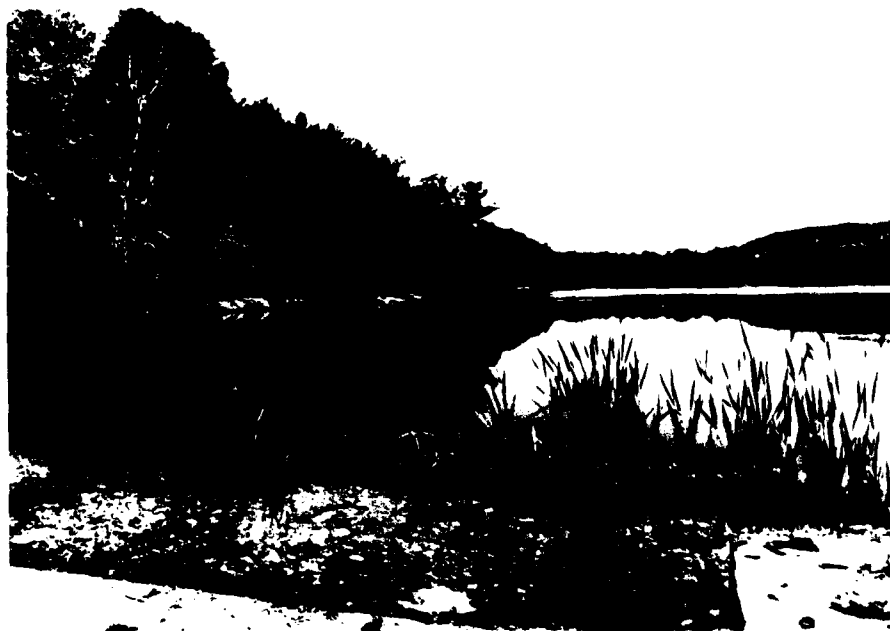
PHOTO NO. 2 - Weed growth immediately upstream of the dam.
